**Flood Control Project Maintenance
Levee Inspections**
LMA District Cover Sheet
Spring 2015 Levee Inspection Results

Reclamation District No. 2058 Pescadero

Levee Inspection Report By Mile - Spring 2015

Waterway	Bank	Unit Miles	Inspection Start/End	Inspector
Unit No. 01 Paradise Cut	Left	6.58	05/12/2015 05/12/2015	Maksim Khashchuk

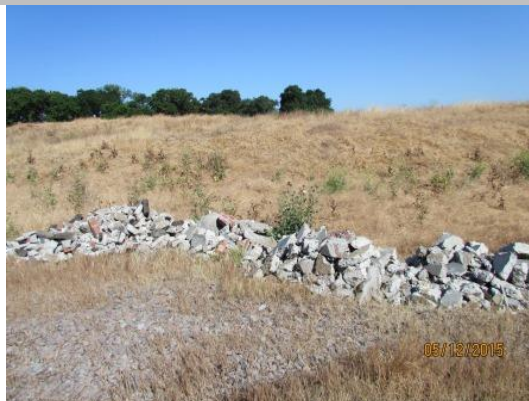
Photo 1 of 1 : SP_2015_RD2058_111_562_20150518_00832.jpg

LM Start	0.14	Rating **	M	Issue No.	562
LM End	0.14	Issue Type +	Ma	Location *	WS
Category	Earthen Levee			GPS Latitude/Longitude	
				Start	End
Item	Encroachments			37.803271 °	37.803271 °
				-121.419533 °	-121.419533 °
DWR ID	DWR_RD2058_01_s_2015_562				
Action/Comments					
Debris					
Inspector Comments: Debris contains asphalt.

View of the concrete and asphalt debris on the waterside levee slope.

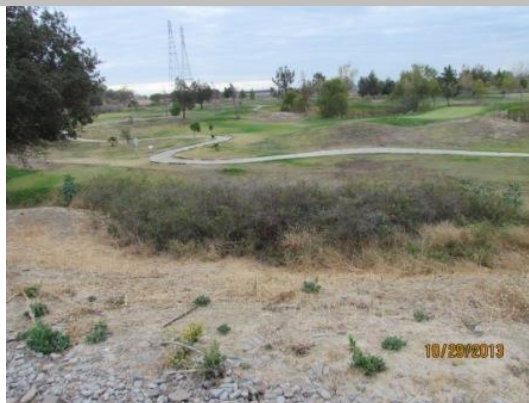
Photo 1 of 1 : SP_2015_RD2058_111_4_20150317_00003.jpg

LM Start	0.23	Rating **	A/W	Issue No.	4
LM End	0.23	Issue Type +	Ob	Location *	LS
Category	Earthen Levee			GPS Latitude/Longitude	
				Start	End
Item	Vegetation			37.804351 °	37.804351 °
				-121.418433 °	-121.418433 °
DWR ID	DWR_RD2058_01_f_2013_4				
Action/Comments					
Environmental Requirements.					
Inspector Comments: Wild rose on the levee. This area is riparian rabbit habitat.

View of the wild rose habitat for the brush rabbit.

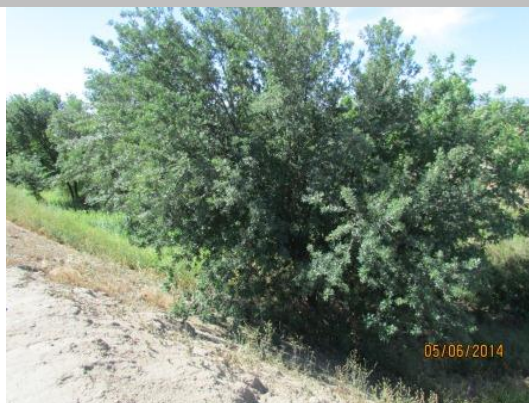
Photo 1 of 1 : SP_2015_RD2058_111_301_20150317_00018.jpg

LM Start	0.50	Rating **	M	Issue No.	301
LM End	0.50	Issue Type +	Ma	Location *	LS
Category	Earthen Levee			GPS Latitude/Longitude	
				Start	End
Item	Trim / Thin Trees			37.802932 °	37.802932 °
				-121.414652 °	-121.414652 °
DWR ID	DWR_RD2058_01_s_2014_301				
Action/Comments					
Trim trees to at least five feet above ground level.

View of the trees at the landside levee toe obstructing visibility and access.

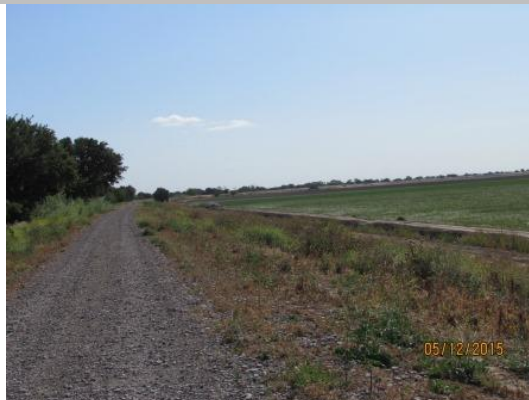
Photo 1 of 1 : SP_2015_RD2058_111_563_20150518_00833.jpg

LM Start	1.25	Rating **	M	Issue No.	563
LM End	1.25	Issue Type +	Ma	Location *	LS
Category	Earthen Levee			GPS Latitude/Longitude	
				Start	End
Item	Vegetation			37.802399 °	37.802399 °
				-121.401558 °	-121.401558 °
DWR ID	DWR_RD2058_01_s_2015_563				
Action/Comments					
Control annual grass and weeds on the levee slopes and easements.

View of the vegetation on the landside levee slope.

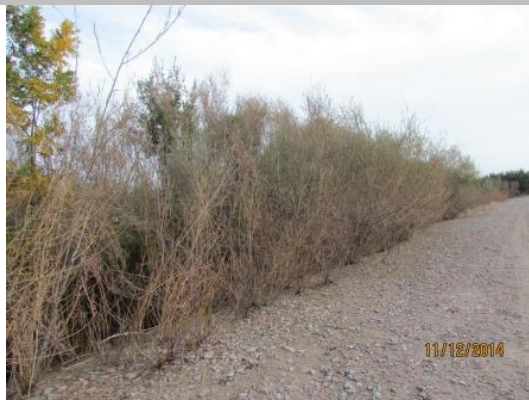
Photo 1 of 1 : SP_2015_RD2058_111_961_20150317_00019.jpg

LM Start	1.70	Rating **	U	Issue No.	961
LM End	1.76	Issue Type +	Ma	Location *	WS
Category	Earthen Levee			GPS Latitude/Longitude	
				Start	End
Item	Vegetation			37.804333 °	37.804615 °
				-121.393657 °	-121.392588 °
DWR ID	DWR_RD2058_01_s_2012_961				
Action/Comments					
Remove the wild growth other than native grasses from the levee slopes.

View if the overgrown vegetation on the waterside slope to be removed.

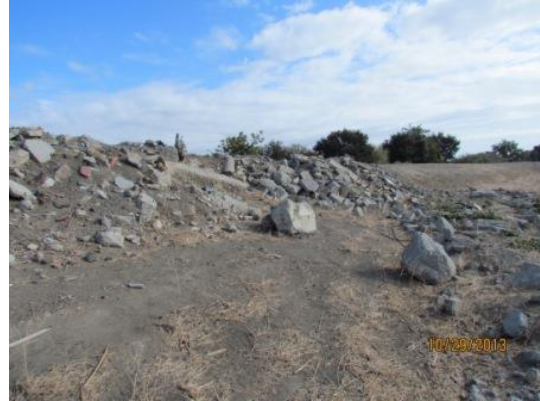
Photo 1 of 1 : SP_2015_RD2058_111_11_20150317_00004.jpg

LM Start	1.82	Rating **	U	Issue No.	11
LM End	1.82	Issue Type +	En	Location *	LS
Category	Earthen Levee			GPS Latitude/Longitude	
				Start	End
Item	Encroachments			37.804785 °	37.804785 °
				-121.391524 °	-121.391524 °
DWR ID	DWR_RD2058_01_f_2013_11				
Action/Comments					
Material					
Inspector Comments: Pile of concrete contains rebar on landside slope obstructing visibility and access.

View of the concrete with rebar placed on the landside slope.

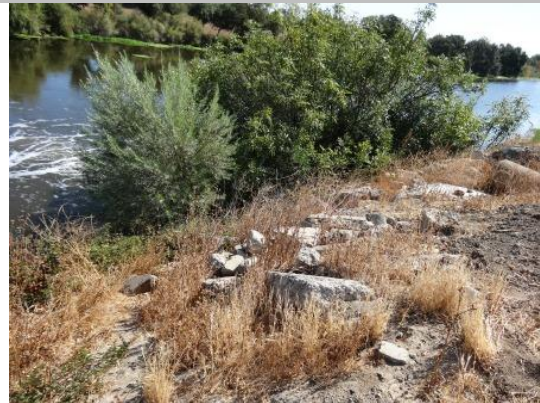
Photo 1 of 1 : SP_2015_RD2058_111_1_20150317_00001.jpg

LM Start	2.12	Rating **	M	Issue No.	1
LM End	2.12	Issue Type +	Ma	Location *	WS
Category	Supplemental			GPS Latitude/Longitude	
				Start	End
Item	DWR Erosion Survey			37.803769 °	37.803769 °
				-121.386341 °	-121.386341 °
DWR ID	DWR_RD2058_01_s_2015_1				
Action/Comments					
Inspector Comments: 08/26/2014: No significant change observed. 08/28/2013: No significant change observed. 07/31/2012: Site was visited on 07/26/2012. No significant change observed. A new vertical pipe was installed and concrete blocks left on the site. Dense vegetation is visible at the site. No signs of new leaks or spill from the siphon breaker. 09/02/2011: Site was not visited due to the time limit. 09/22/2010: No significant change observed. Vegetation downstream, upstream and on the lower slope of the site have been recently sprayed. These areas were also fenced off during the site visit, making it difficult for us to examine the condition of the lower slope. Possible leak or spill from the siphon breaker is creating notches along the slope and developing into a headward erosion. If the problem continues, it will erode the slope and fully expose the pipe to outside elements. 07/23/2009: A possible leak or spill from a siphon breaker is eroding the slope and developing into a headward erosion; a portion of the buried pipe is exposed; the lower slope seems to be lined with chunks of concrete debris or other rock material. [2014 Site ID:RD2058U01RM1.78]

Direct view of the site.

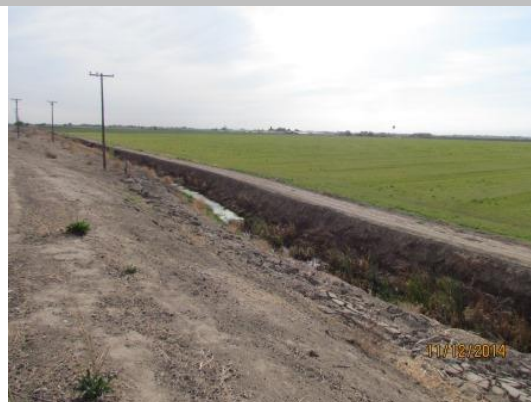
Photo 1 of 1 : SP_2015_RD2058_111_12_20150317_00005.jpg

LM Start	2.24	Rating **	M	Issue No.	12
LM End	2.30	Issue Type +	En	Location *	LS
Category	Earthen Levee			GPS Latitude/Longitude	
				Start	End
Item	Encroachments			37.803375 °	37.803136 °
				-121.384196 °	-121.383078 °
DWR ID	DWR_RD2058_01_f_2013_12				
Action/Comments					
Ditch

View of the ditch at the landside levee toe.

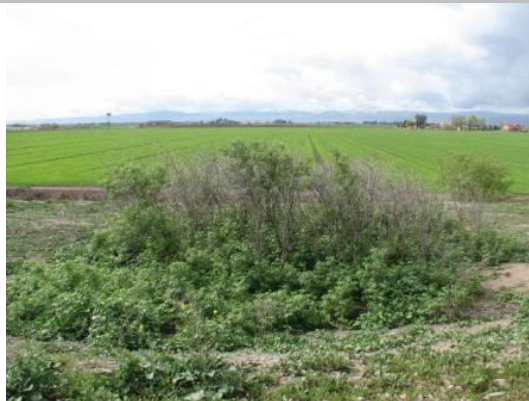
Photo 1 of 1 : SP_2015_RD2058_111_16_20150317_00007.jpg

LM Start	2.39	Rating **	A/W	Issue No.	16
LM End	2.39	Issue Type +	Ma	Location *	LS
Category	Earthen Levee			GPS Latitude/Longitude	
				Start	End
Item	Vegetation			37.802782 °	37.802782 °
				-121.381413 °	-121.381413 °
DWR ID	DWR_RD2058_01_s _ 2012_16				
Action/Comments					
Elderberries are blocking visibility and flood fight capability. Inspector Comments: Elderberry growing on landside toe.

03/28/2012 Large elderberry bush on landside slope.

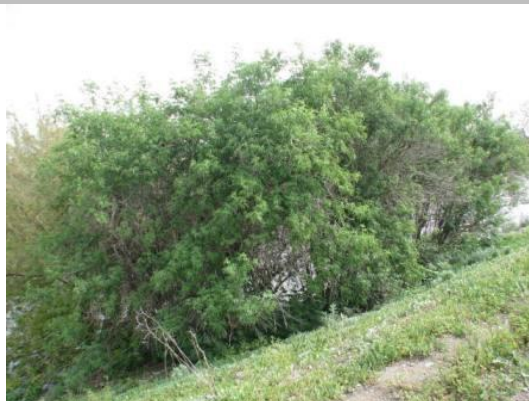
Photo 1 of 1 : SP_2015_RD2058_111_63_20150317_00017.jpg

LM Start	2.61	Rating **	A/W	Issue No.	63
LM End	2.61	Issue Type +	Ma	Location *	WS
Category	Earthen Levee			GPS Latitude/Longitude	
				Start	End
Item	Vegetation			37.801962 °	37.801962 °
				-121.377684 °	-121.377684 °
DWR ID	DWR_RD2058_01_s _ 2012_63				
Action/Comments					
Elderberries are blocking visibility and flood fight capability. Inspector Comments: Elderberry on waterside slope.

03/28/2012 Large elderberry bush located on waterward slope.

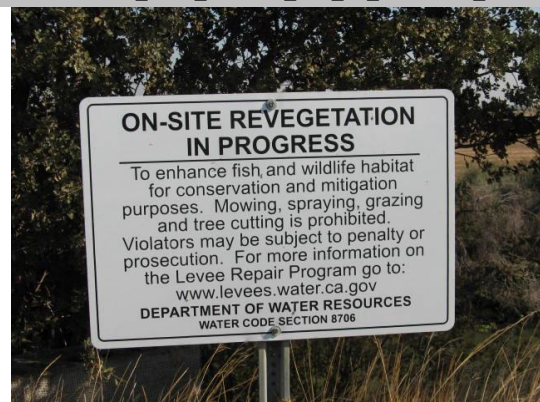
Photo 1 of 1 : SP_2015_RD2058_111_20_20150317_00008.jpg

LM Start	3.80	Rating **	A/W	Issue No.	20
LM End	3.80	Issue Type +	Ob	Location *	WS
Category	Earthen Levee			GPS Latitude/Longitude	
				Start	End
Item	Vegetation			37.790807 °	37.790807 °
				-121.362905 °	-121.362905 °
DWR ID	DWR_RD2058_01_s _ 2012_20				
Action/Comments					
Environmental Requirements.					
Inspector Comments: Revegetation site.

11/08/2011 Revegetation site, cannot trim or cut vegetation in this area.

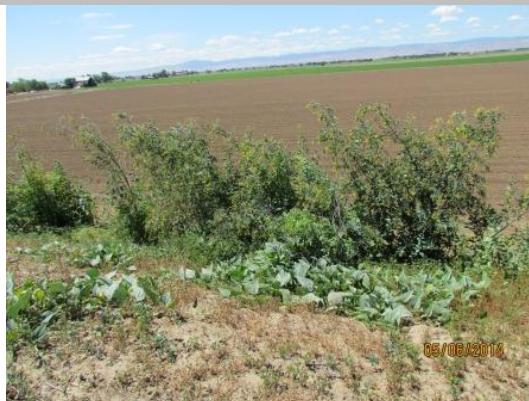
Photo 1 of 1 : SP_2015_RD2058_111_22_20150317_00009.jpg

LM Start	3.91	Rating **	M	Issue No.	22
LM End	3.91	Issue Type +	Ma	Location *	LS
Category	Earthen Levee			GPS Latitude/Longitude	
				Start	End
Item	Vegetation			37.789434 °	37.789434 °
				-121.361721 °	-121.361721 °
DWR ID	DWR_RD2058_01_s _ 2014_22				
Action/Comments					
Remove the wild growth other than native grasses from the levee slopes.

View of the tall vegetation on the landside levee slope and toe.

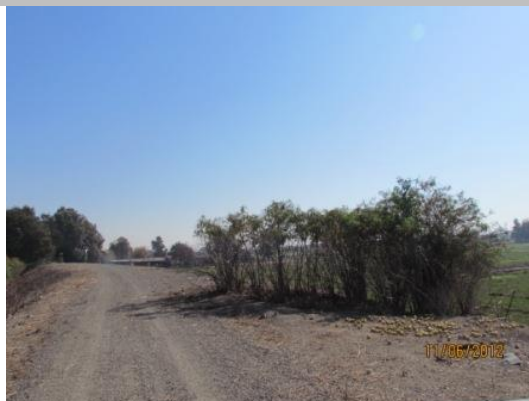
Photo 1 of 1 : SP_2015_RD2058_111_26_20150317_00010.jpg

LM Start	3.96	Rating **	M	Issue No.	26
LM End	3.96	Issue Type +	Ma	Location *	LS
Category	Earthen Levee			GPS Latitude/Longitude	
				Start	End
Item	Vegetation			37.789128 °	37.789128 °
				-121.361042 °	-121.361042 °
DWR ID	DWR_RD2058_01_s _ 2012_26				
Action/Comments					
Elderberries are blocking visibility and flood fight capability. Inspector Comments: Elderberry on landside hinge point.

Elderberry bushes on landside slope.

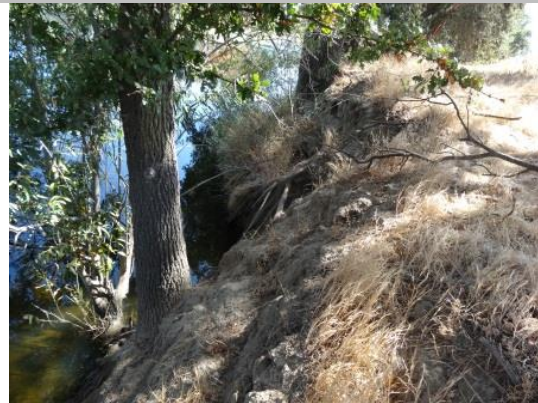
Photo 1 of 1 : SP_2015_RD2058_111_2_20150317_00002.jpg

LM Start	4.45	Rating **	M	Issue No.	2
LM End	4.45	Issue Type +	Ma	Location *	WS
Category	Supplemental			GPS Latitude/Longitude	
				Start	End
Item	DWR Erosion Survey			37.789810 °	37.789810 °
				-121.352490 °	-121.352490 °
DWR ID	DWR_RD2058_01_s _ 2015_2				
Action/Comments					
Inspector Comments: 08/26/2014: No significant change observed. 08/28/2013: No significant change observed. 07/26/2012: The site has been visited, and no significant change has been observed. 09/02/2011: This site was not visited due to the time limit. 09/22/2010: No significant change observed. Minor pocket erosions are lined at the lower bank. Two large Oak and Willow trees are on mid-slope and bench. The remaining bench was re-measured and found to be approximately 10 feet. There was no indication of active erosion on site during the site visit. 08/05/2010: Recommended for annual assessment and monitoring of the site during flood events, per CLRO. 07/23/2009: No major change observed since last visit; site is a 200-ft. long near-vertical berm erosion; recommend annual assessment and monitoring of the erosion site, per CLRO CES Evaluation 2008 Report; Site # is the same site previously reported as RM4.0,LM4.51; previously rated "U". 09/10/2008: Two large trees (2-3' DBH) with partial roots exposed. 2007: Visited site 03/13/2007. [2014 Site ID:RD2058U01RM3.97]

Direct view of the erosion near a tree.

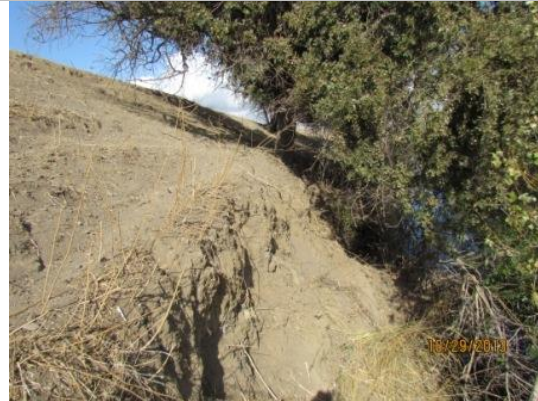
Photo 1 of 1 : SP_2015_RD2058_111_15_20150317_00006.jpg

LM Start	4.77	Rating **	U	Issue No.	15
LM End	4.77	Issue Type +	Ma	Location *	WS
Category	Earthen Levee			GPS Latitude/Longitude	
				Start	End
Item	Erosion / Bank Caving			37.785862 °	37.785862 °
				-121.350303 °	-121.350303 °
DWR ID	DWR_RD2058_01_f_2013_15				
Action/Comments					
Note and monitor erosion site.					
Inspector Comments: The erosion has about a 3 foot vertical cut at the waterside levee toe.

View of the erosion at the waterside levee toe.

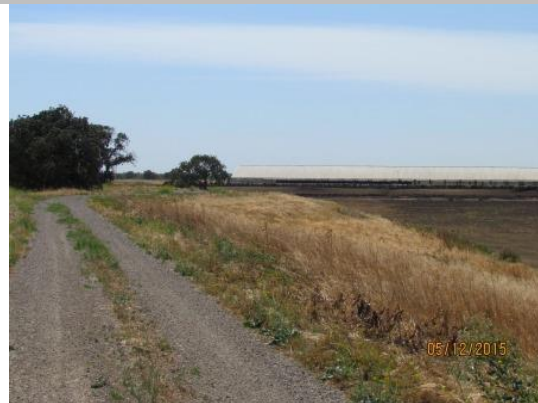
Photo 1 of 1 : SP_2015_RD2058_111_564_20150518_00834.jpg

LM Start	4.91	Rating **	M	Issue No.	564
LM End	4.91	Issue Type +	Ma	Location *	LS
Category	Earthen Levee			GPS Latitude/Longitude	
				Start	End
Item	Vegetation			37.784378 °	37.784378 °
				-121.348562 °	-121.348562 °
DWR ID	DWR_RD2058_01_s_2015_564				
Action/Comments					
Control annual grass and weeds on the levee slopes and easements.

View of the vegetation on the landside levee slope.

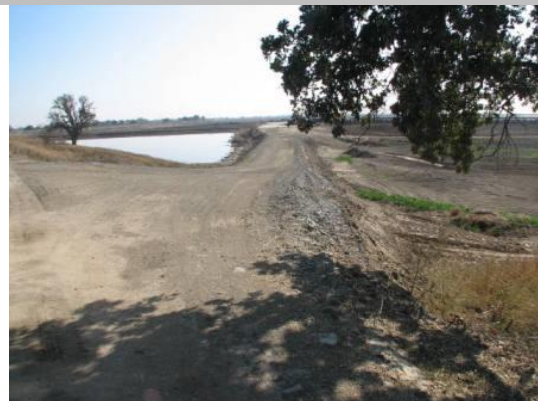
Photo 1 of 3 : SP_2015_RD2058_111_29_20150317_00011.jpg

LM Start	5.10	Rating **	U	Issue No.	29
LM End	5.10	Issue Type +	En	Location *	LS
Category	Earthen Levee			GPS Latitude/Longitude	
				Start	End
Item	Encroachments			37.783102 °	37.783102 °
				-121.345682 °	-121.345682 °
DWR ID	DWR_RD2058_01_s_2012_29				
Action/Comments					
Ramp Inspector Comments: New ramp construction connecting dairy to levee. Construction of ramp results in a new pond on the landside of the levee. 2/21/2012, owner has said that he will contact the CVFPB to resolve this issue.

11/08/2011 New ramp has been constructed by Dairy farmer connecting his barns to the levee.

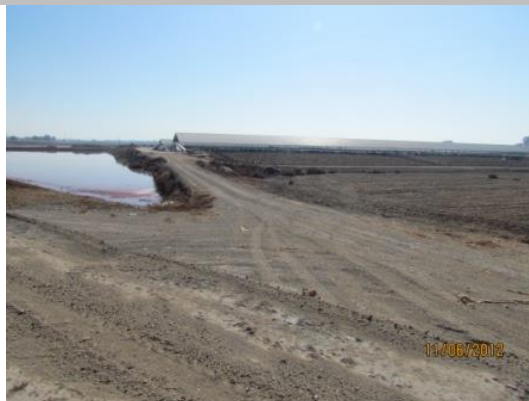
Photo 2 of 3 : SP_2015_RD2058_111_29_20150317_00012.jpg

LM Start	5.10	Rating **	U	Issue No.	29 (cont)
LM End	5.10	Issue Type +	En	Location *	LS
Category	Earthen Levee			GPS Latitude/Longitude	
				Start	End
Item	Encroachments			37.783102 °	37.783102 °
				-121.345682 °	-121.345682 °
DWR ID	DWR_RD2058_01_s _ 2012_29				
Action/Comments					
Ramp Inspector Comments: New ramp construction connecting dairy to levee. Construction of ramp results in a new pond on the landside of the levee. 2/21/2012, owner has said that he will contact the CVFPB to resolve this issue.

Completed new ramp constructed by Dairy farmer connecting his barns to the levee.

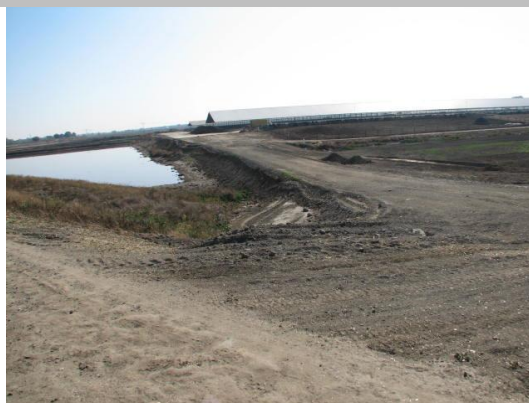
Photo 3 of 3 : SP_2015_RD2058_111_29_20150317_00013.jpg

LM Start	5.10	Rating **	U	Issue No.	29 (cont)
LM End	5.10	Issue Type +	En	Location *	LS

11/08/2011 New ramp has been constructed by Dairy farmer connecting his barns to the levee.

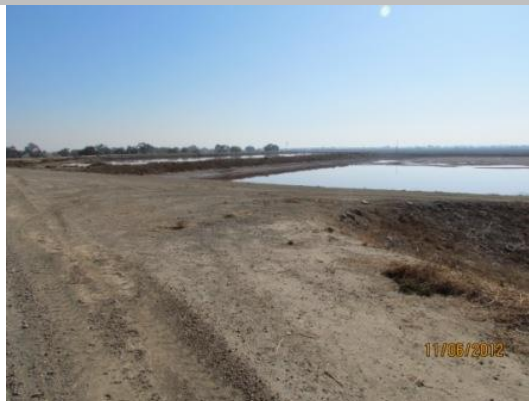
Photo 2 of 3 : SP_2015_RD2058_111_30_20150317_00015.jpg

LM Start	5.29	Rating **	U	Issue No.	30 (cont)
LM End	5.29	Issue Type +	En	Location *	LS
Category	Earthen Levee			GPS Latitude/Longitude	
				Start	End
Item	Encroachments			37.782268 °	37.782268 °
				-121.342257 °	-121.342257 °
DWR ID	DWR_RD2058_01_s _ 2012_30				
Action/Comments					
Ramp					
Inspector Comments: Ramp constructed to dairy. Raised ramps, see issue 29 are creating new holding ponds for dairy at levee toe.

Completed new ramp constructed by Dairy farmer connecting his barns to the levee.

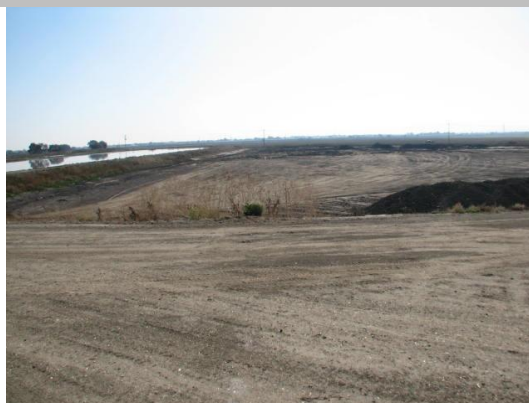
Photo 3 of 3 : SP_2015_RD2058_111_30_20150317_00016.jpg

LM Start	5.29	Rating **	U	Issue No.	30 (cont)
LM End	5.29	Issue Type +	En	Location *	LS

11/08/2011 Photo shows view from the levee looking to the left of the middle ramp.
